Pre-Impact Damage Assessment Using X-ray Tomography of SiC Tile Encapsulated In Discontinuously Reinforced Aluminum Metal Matrix Composite.

Joseph M. Wells, William H. Green, and Nevin L. Rupert

U.S. Army Research Laboratory

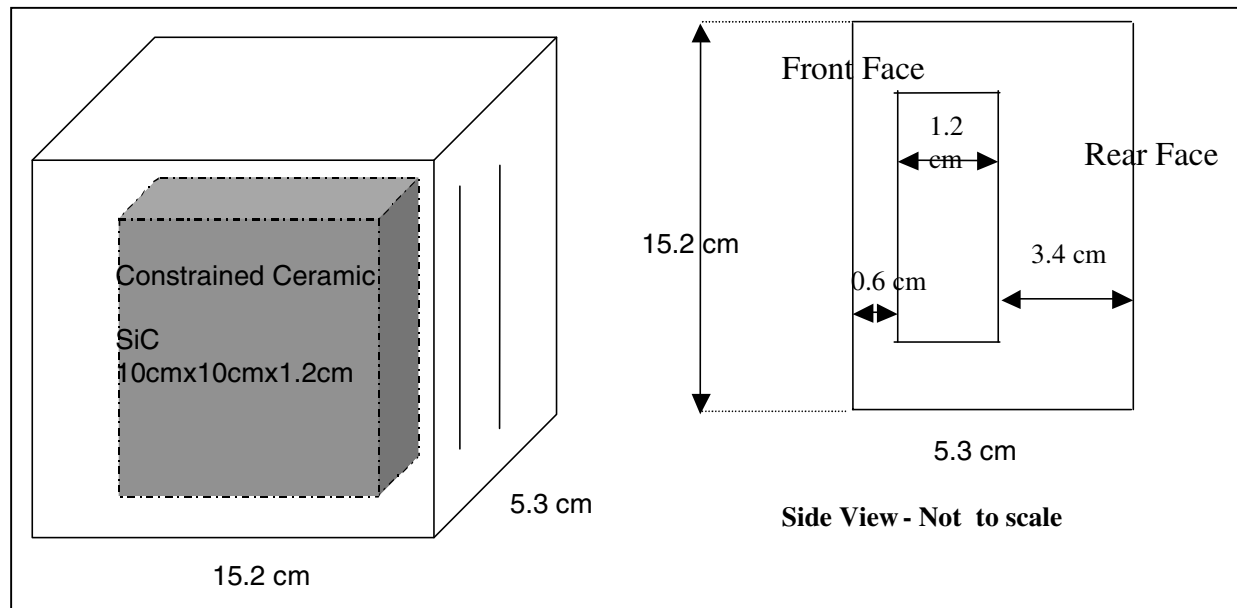
The samples used in this study were sized the same as those used by Horwath & Bruchey [2] for their EBW/HIP Titanium Ti-6Al-4V alloy encapsulated samples. A schematic of the sample dimensions is shown in Figure 1. The differences with the present samples are that the encapsulation material was a highly filled, discontinuously reinforced aluminum alloy metal matrix composite. A comparison of selected properties between the Ti-6Al-4V and the DRA MMC material are shown in Table 1.

Figure 1. Encapsulated Ceramic / DRA Sample Configuration used for both the Pressure Infiltrated and the Pressureless Infiltration Casting processes.

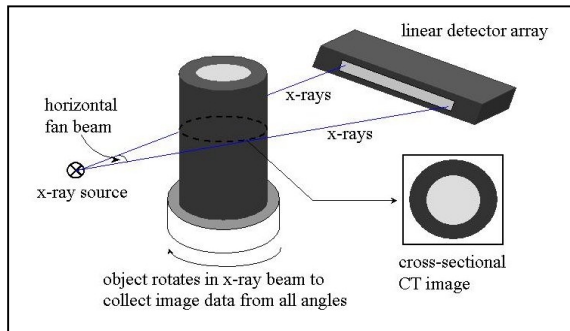
2.3.1 **Equipment** – The samples were inspected using a customized ACTIS 600/420 computed tomography system designed and constructed by Bio-Imaging Research, Inc., and installed at the U.S. Army Research Laboratory at Aberdeen Proving Ground (APG), Maryland. The system has a 420 keV x-ray tube with two focal spot sizes and a 160 keV microfocus x-ray tube with four focal spot sizes, the smallest being 10 microns. It has a linear detector array (LDA) and an image intensifier with a zoom lens and a charged-coupled device (CCD) camera. Computed tomography scanning can be done using the LDA or the image intensifier (II). The system can scan in rotate-only (RO) and offset-RO mode using the LDA or the II as shown in Figure 2, and in translate-rotate (TR) mode using the LDA. It can also perform digital radiography (DR) scans using the LDA or II as shown in Figure 3.

Figure 2. Schematic of the Rotate-Only (RO) Computed Tomography Scan

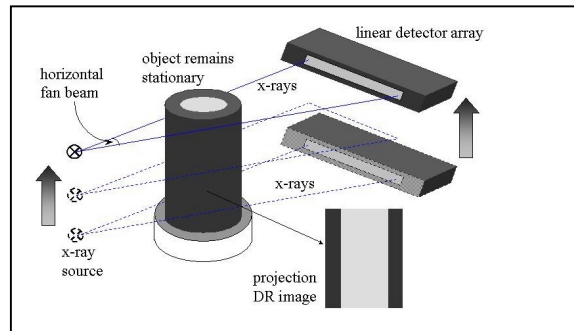
Figure 3. Schematic of the Digital Radiography Technique

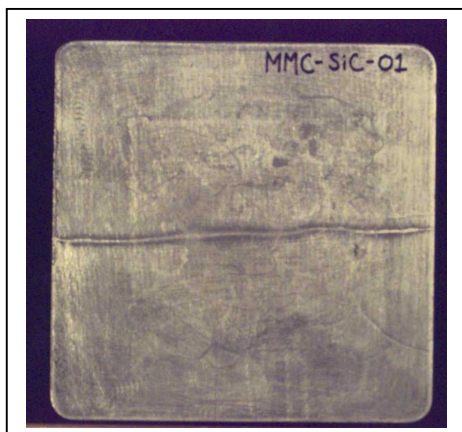
3.1 **Visual Inspection** – Digital macro-photographs were taken of each sample as received from the casting supplier. Photomacrographs of the front surface of each sample are shown in Figure 4. Indications of cracking are visible on the front surface of all three pressure infiltrated samples as shown in in Figure 4 (a),(b) and (c). No such indications were observed on the front surface of the pressure-less infiltration sample in Figure 4 (d).

Figure 4 (a). Front surface of sample MMC-01 with cracking visible.

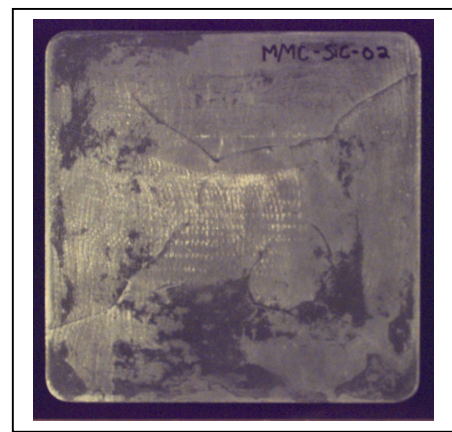
Figure 4 (b). Front surface of sample MMC-02 with cracking visible.

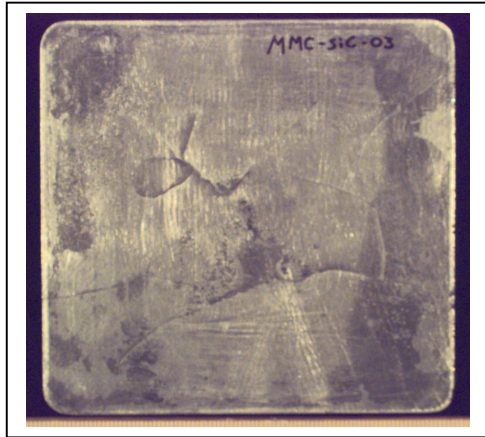
Figure 4 (c). Front surface of sample MMC-03 with cracking visible.

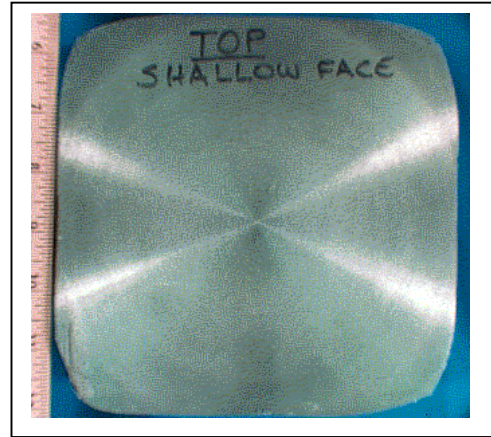
Figure 4 (d). Front surface of sample MMC-04 with no surface cracking observed.

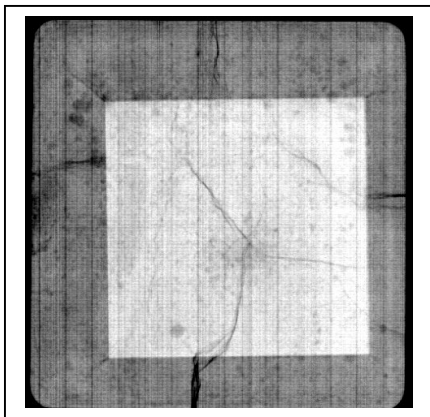
3.2 Digital Radiography– A digital radiograph, DR, in the through thickness direction was taken of each sample. These are shown in Figure 5 (a), (b), and (c) for samples MMC-01, MMC-02, and MMC-03, respectively. The purely vertical streaking in each DR is an image artifact and does not correspond to material or structural differences in the samples. A substantial amount of cracking is evident in each of the pressure infiltrated samples, Figures 5(a), (b) and (c). Also, the internal SiC tile, which appears lighter than the surrounding matrix, is not centered top-to-bottom, nor centered left-to-right, tilted to some degree, or some combination of these translational conditions. Note that it is not evident from the DR whether such cracking extends from the MMC into the SiC tile material or remains in the projected MMC plane in front of and/or behind the tile. Similarly, no tile displacement toward or away from the front face of the sample is discernable in the DR. Neither cracking nor SiC tile displacement was observed in the conventional radiograph of the pressureless infiltration sample MMC-04.

Figure 5(a). Digital Radiograph of Sample MMC-01.

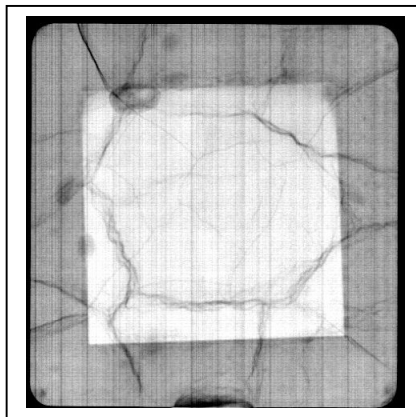
Figure 5(b). Digital Radiograph of Sample MMC-02.

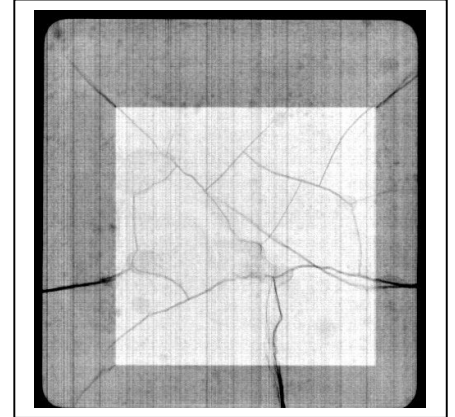
Figure 5(c). Digital Radiograph of Sample MMC-03.

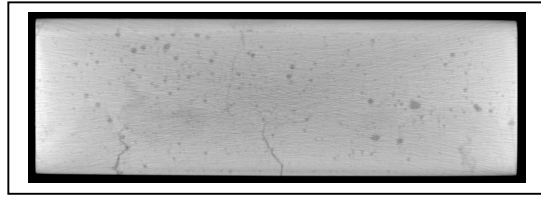
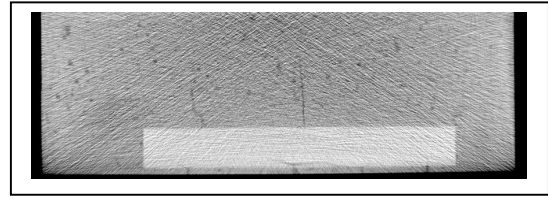
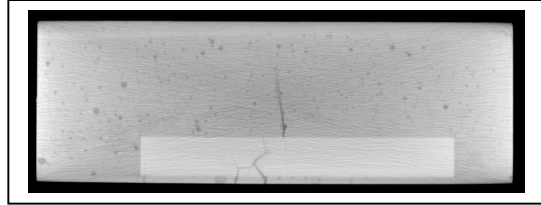
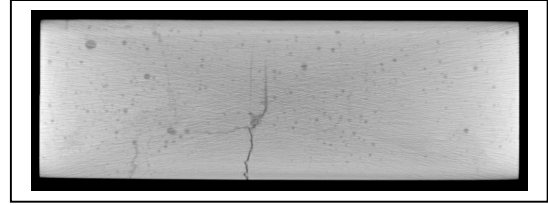
Figure 6 is a representative series of four CT images in which the front face of the sample MMC-01 is at the bottom of the image. Cracking in both the DRA material and the SiC tile is evident in these cross sectional reconstructed views. This cracking appears predominantly initiating on the front face and, in Figure 6 (c), continues directly into the SiC tile. The tile has moved during the pressure infiltration process and is now only about 2mm from the front face of the sample. Porosity up to about 3 mm in diameter is also observed in the DRA material in these cross sectional CT views

(a) Above top of SiC tile Sample MMC-01

(b) Near lower quarter of tile (48 mm)

(c) Near bottom of tile

(d) Near bottom of sample MMC-01

Figure 6 (a) to (d) showing x-ray CT scans across various cross sectional positions of sample MMC-01. Note the cracking in both the DRA and the SiC tile materials and the forward translation of tile.

- Substantial pre-existing flaws including cracking in both the DRA encapsulating material and in the monolithic SiC ceramic tile were observed in the samples cast with the Pressure Infiltration technique. Size, location, orientation, and shape of flaws were observed and recorded to establish a “pre-impact” baseline for planned subsequent examination following ballistic impact. A significant forward displacement and tilting of the SiC tile was detected resulting from the Pressure Infiltration Casting process where inadequate tile restraint was incorporated in the mold/preform. This displacement of the monolithic SiC tile is significant both in the through thickness and in the orthogonal planar directions. Such cracking and tile displacement are undesirable and were clearly detected and adequately characterized by the nondestructive x-ray tomography method so as to justify the postponement of the planned subsequent ballistic testing of these samples.

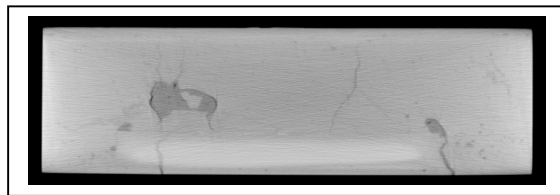
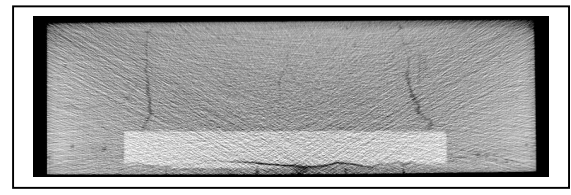
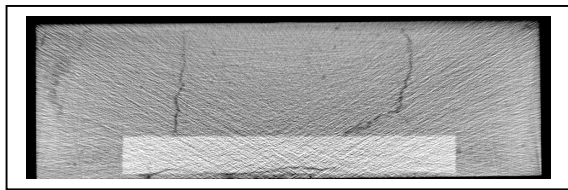
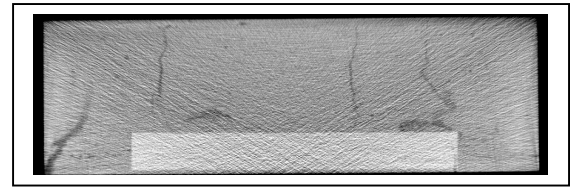
Figure 7 is a similar series of CT images for sample MMC-02. Large inclusions and extensive cracking in the DRA material is evident, as well as cracking in the SiC tile. There is a relatively thin void area to the left of the large inclusion. Also, the corners and some of the edges of the tile in Figure 7 (a) are missing. Again, the tile is within only a few millimeters of the front face of the sample demonstrating the plate was displaced during the DRA pressure infiltration casting process. Note that extensive lateral cracking has occurred along the front face of the SiC tile as shown in Figures 7 (b) and (c).

(a) Neat top of tile in Sample MMC-02

(b) Upper tile quarter section (105 mm)

(c) Lower quarter tile section (53mm)

(d) Near bottom of Tile in Sample MMC-02

Figure 7 (a) to (d) showing x-ray CT scans across various cross sectional positions of sample MMC-02. Note the large inclusions and extensive cracking in the DRA and both transverse and lateral cracks in the SiC tile material.

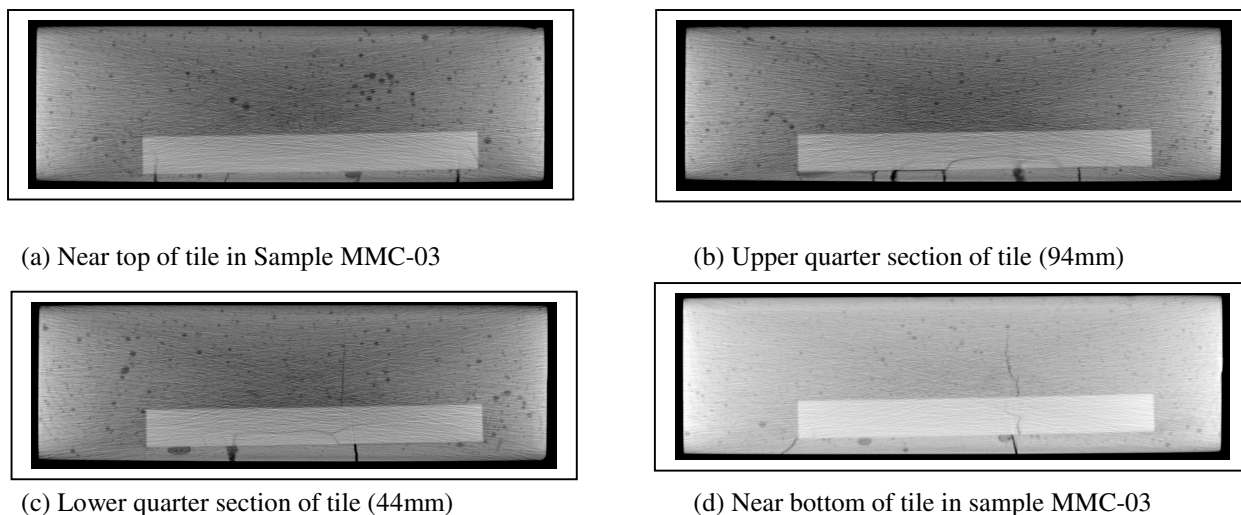
Figure 8 is the series of CT images for sample MMC-03. Again, cracking in both the DRA material and the SiC tile is evident in this sample as well. Prominent cracks originating on the front face are seen to bridge the DRA material perpendicular to the tile, and turn laterally once into the SiC tile as shown in Figures 8 (b) and (c). The tile is not horizontally centered and is tilted with respect to the front face of the sample. Lastly, the tile is closer from the front face near the top of the sample than it is near the bottom of the sample, indicating a vertical tilting as well.

Figure 8 (a) to (d) showing x-ray CT scans across various cross sectional positions of sample MMC-03. Note the prominent cracking in front face of the DRA and turning transversely in the SiC tile.
